## **Parcel C Remedial Action**

# **Project Update for Parcel C Hunters Point Naval Shipyard San Francisco, California**

**BCT Meeting October 24, 2013**

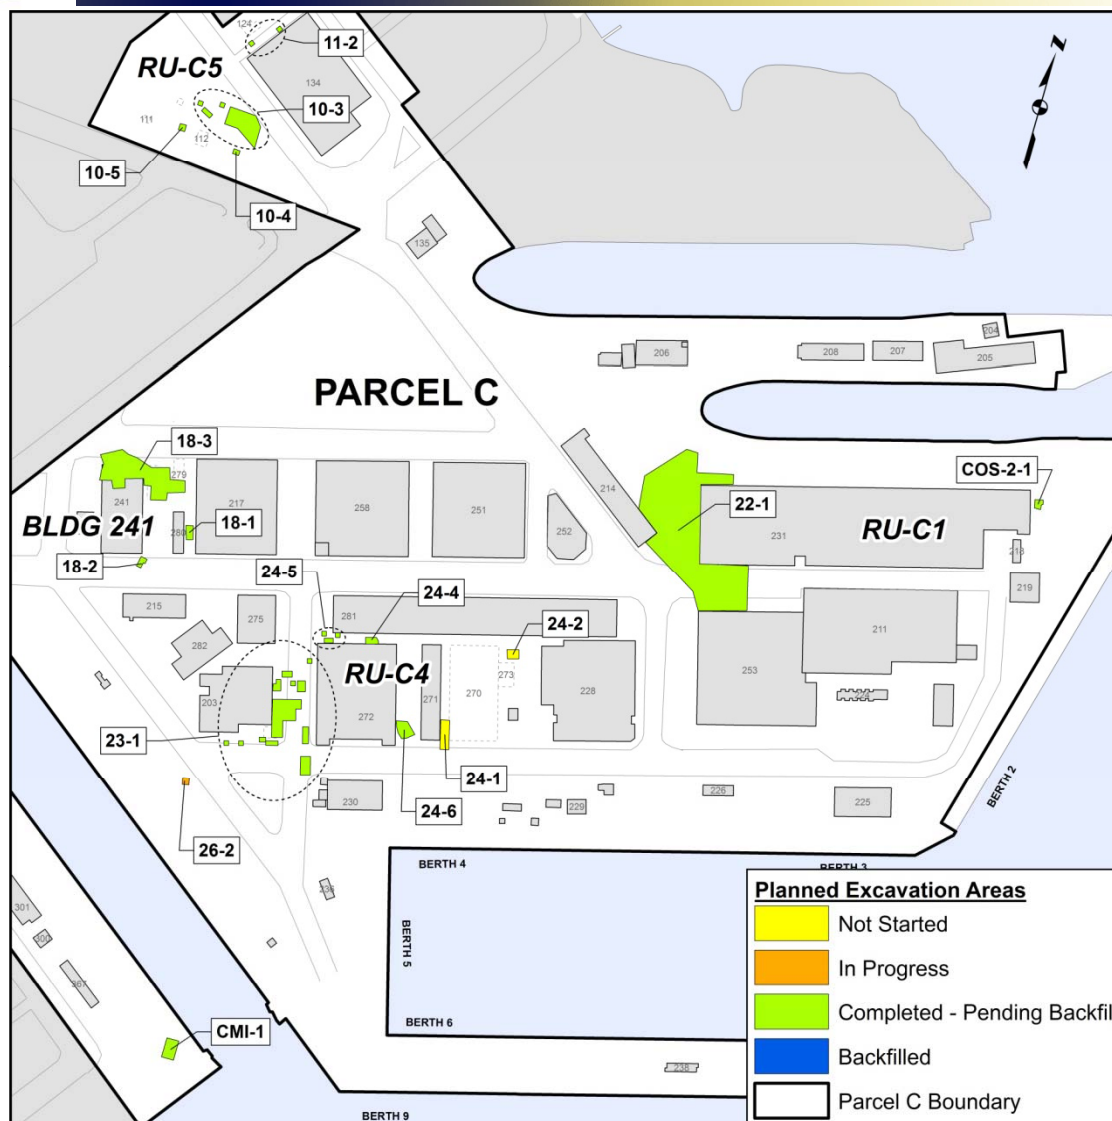
# Excavation Progress

Approximately 18,460 bcy have been excavated and stockpiled (Oct 17, 2013). A total of 22,300 bcy is anticipated to be removed (not including step-outs and/or benching).

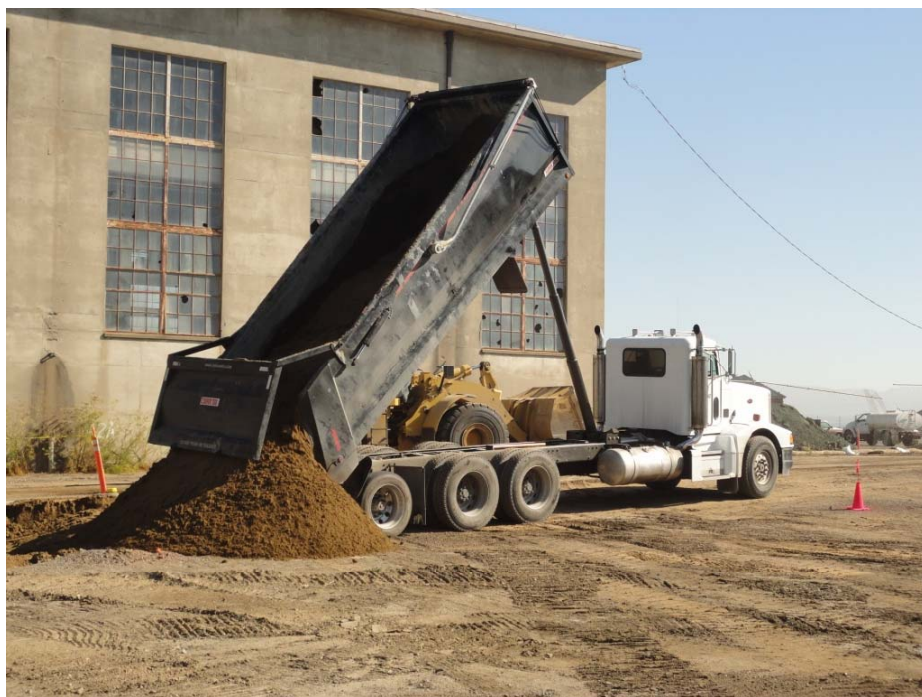
Import of clean backfill for direct placement in RU-C5 (Oct 18, 2013)

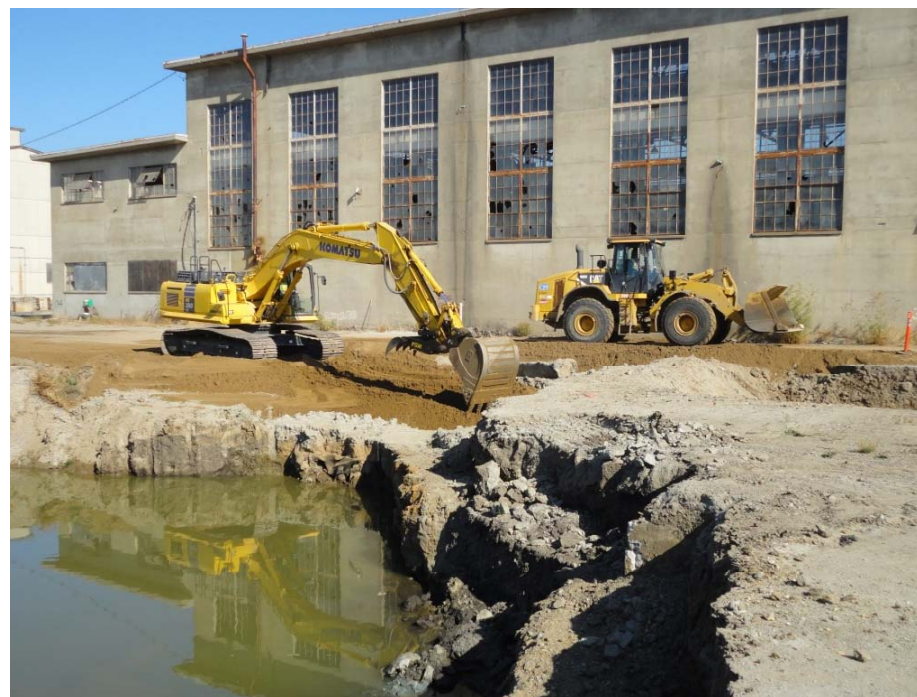
Backfill placement in Excavation 10-3, Bldg 134 in background - facing south (Oct 18, 2013)

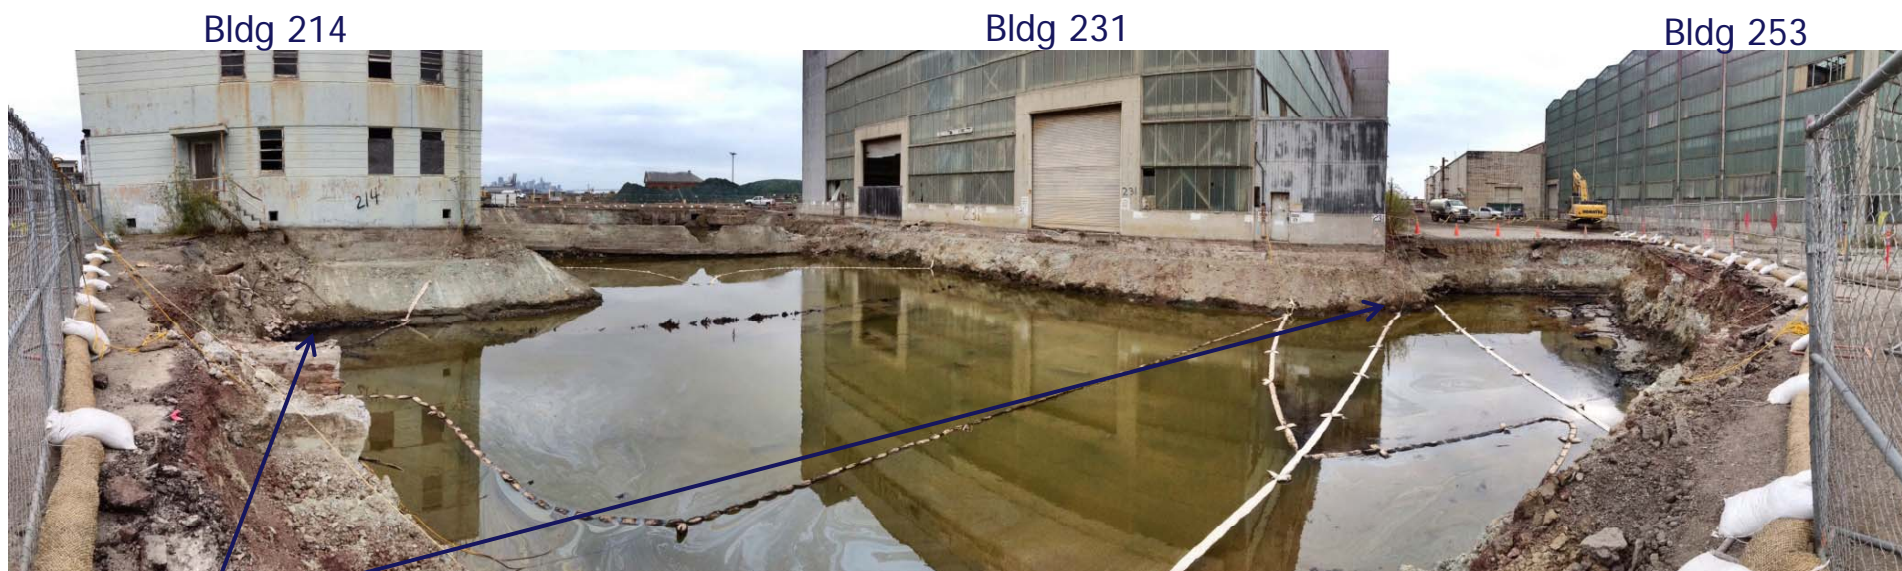
- 22-1 excavation footprint has been completed up to another contractor's RCA that overlaps the southwest portion of the footprint. All initial samples have been collected and results received. Step-outs have been taken as accessible.
  - Oily material at corner of Bldg 214 and 231 remains to be addressed

TPH observed

Panoramic view of Excavation 22-1 facing east – September, 2013

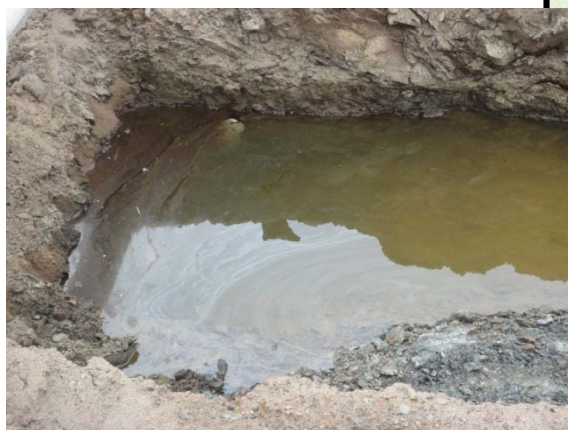
- 2,820 bcy excavated as of 10/17 (planned 3,398 bcy)
- All accessible excavations within RU-C4 have been excavated and sampled (results pending)
- Encountered bedrock in several excavations - depths and horizontal boundaries were adjusted
- Three excavations are still in other contractor's RCA – to be completed once area is radiologically down-posted
- One excavation area within Excavation 23-1 (labeled 23-1E) exhibited noticeable TPH coming from sidewalls and bottom of excavation

Excavation 23-1E  
with noticeable TPH

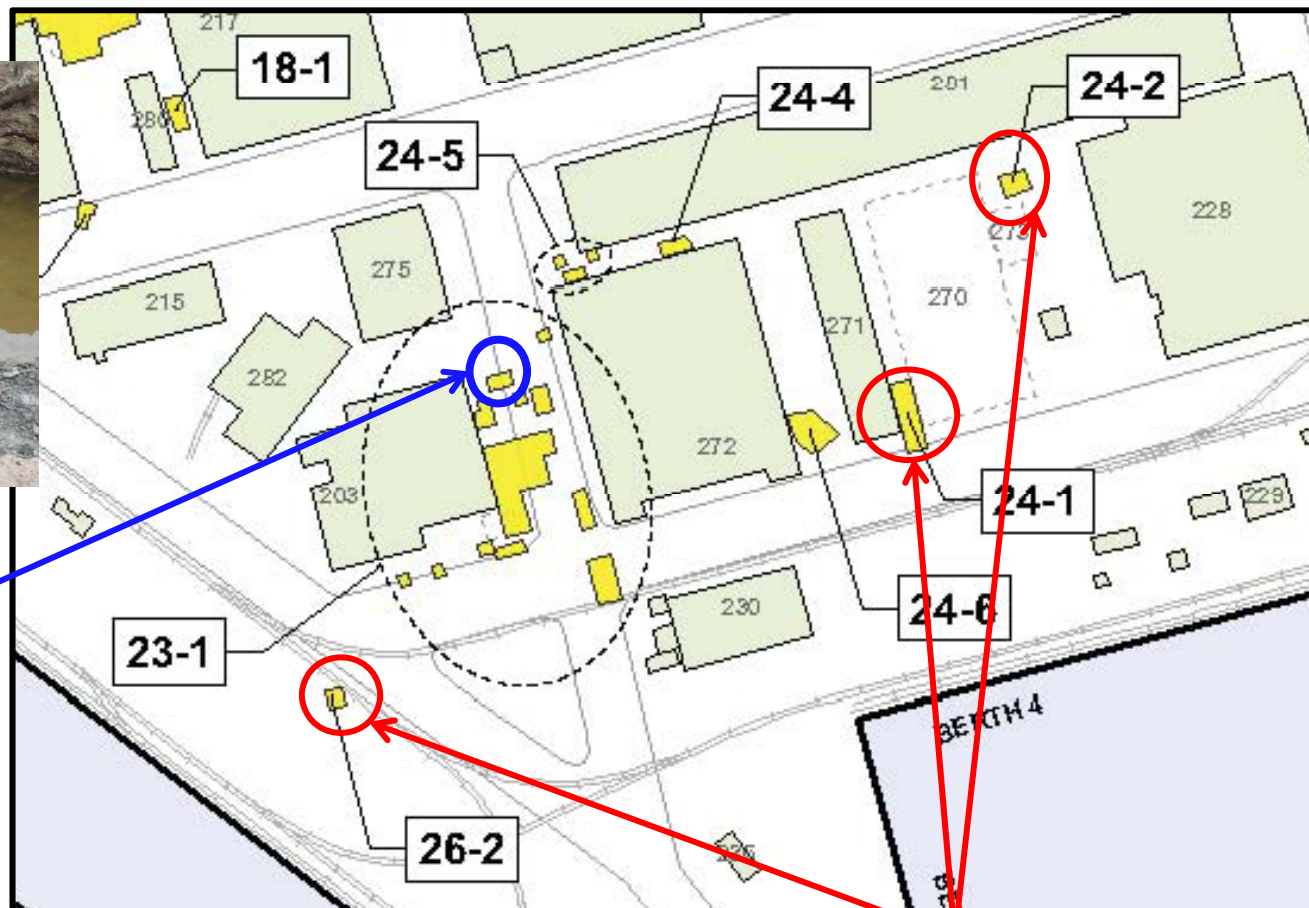
Areas behind RCA fence

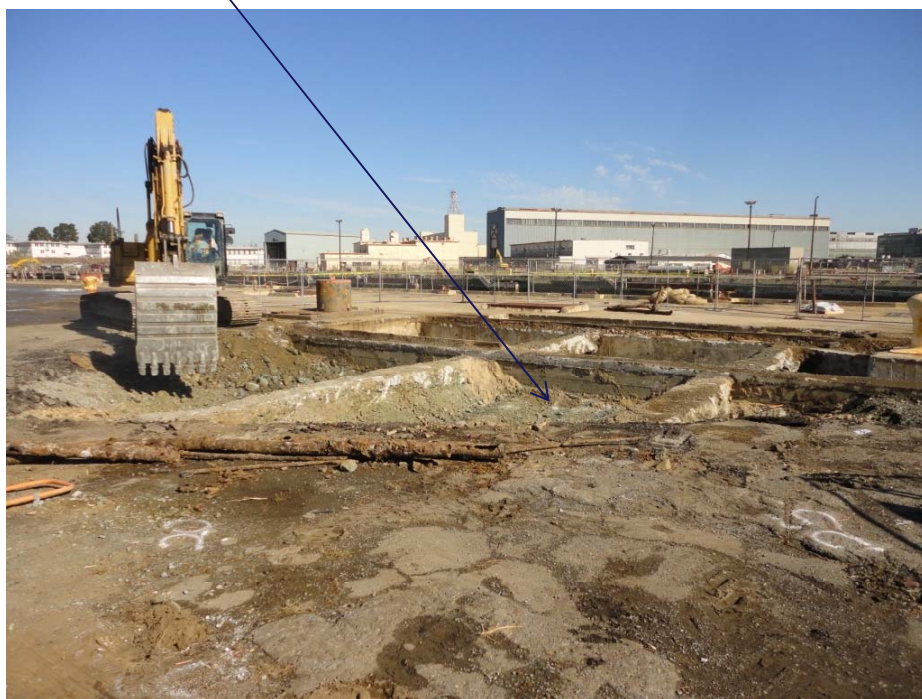
Solid bedrock

Excavation CMI-1 with concrete structures and bedrock, facing east (Oct 8)

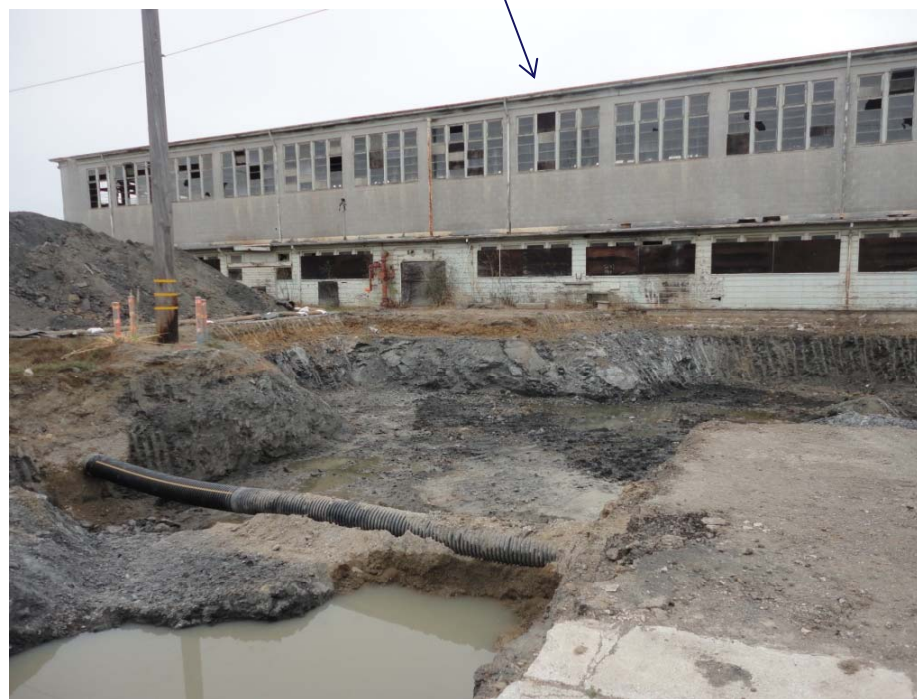
Completed Excavation 18-3 – facing west (Oct 21)

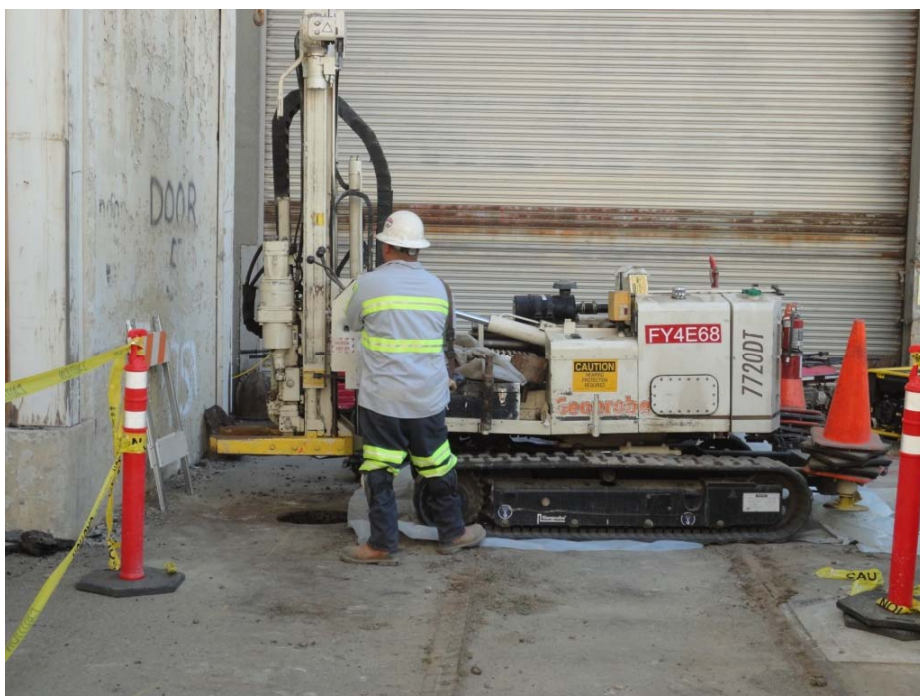
Driller setting up in SVE Area 8 (Oct 7)

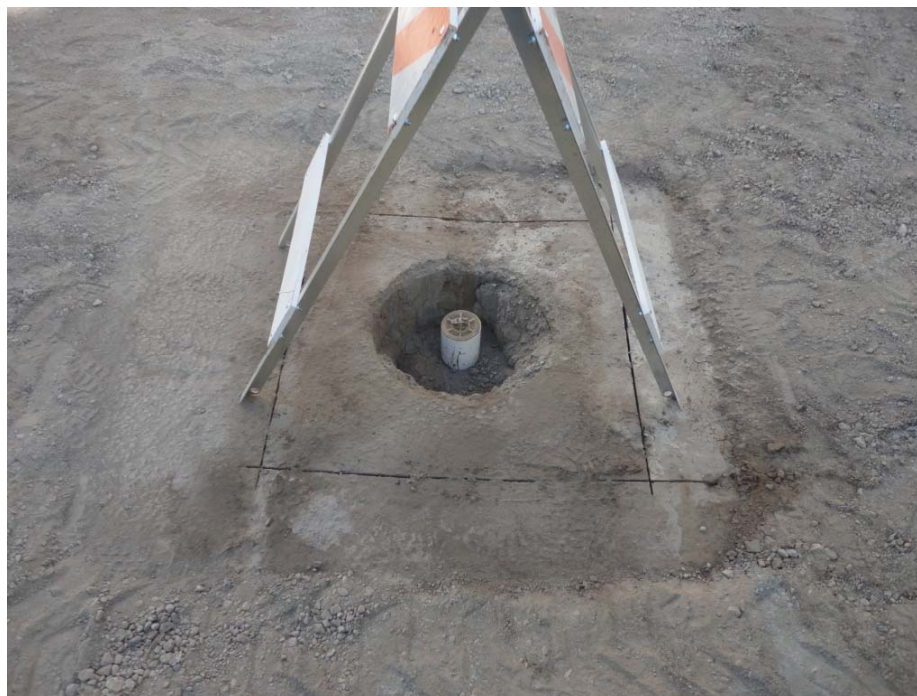
Soil vapor extraction point in SVE Area 8 (Oct 7)

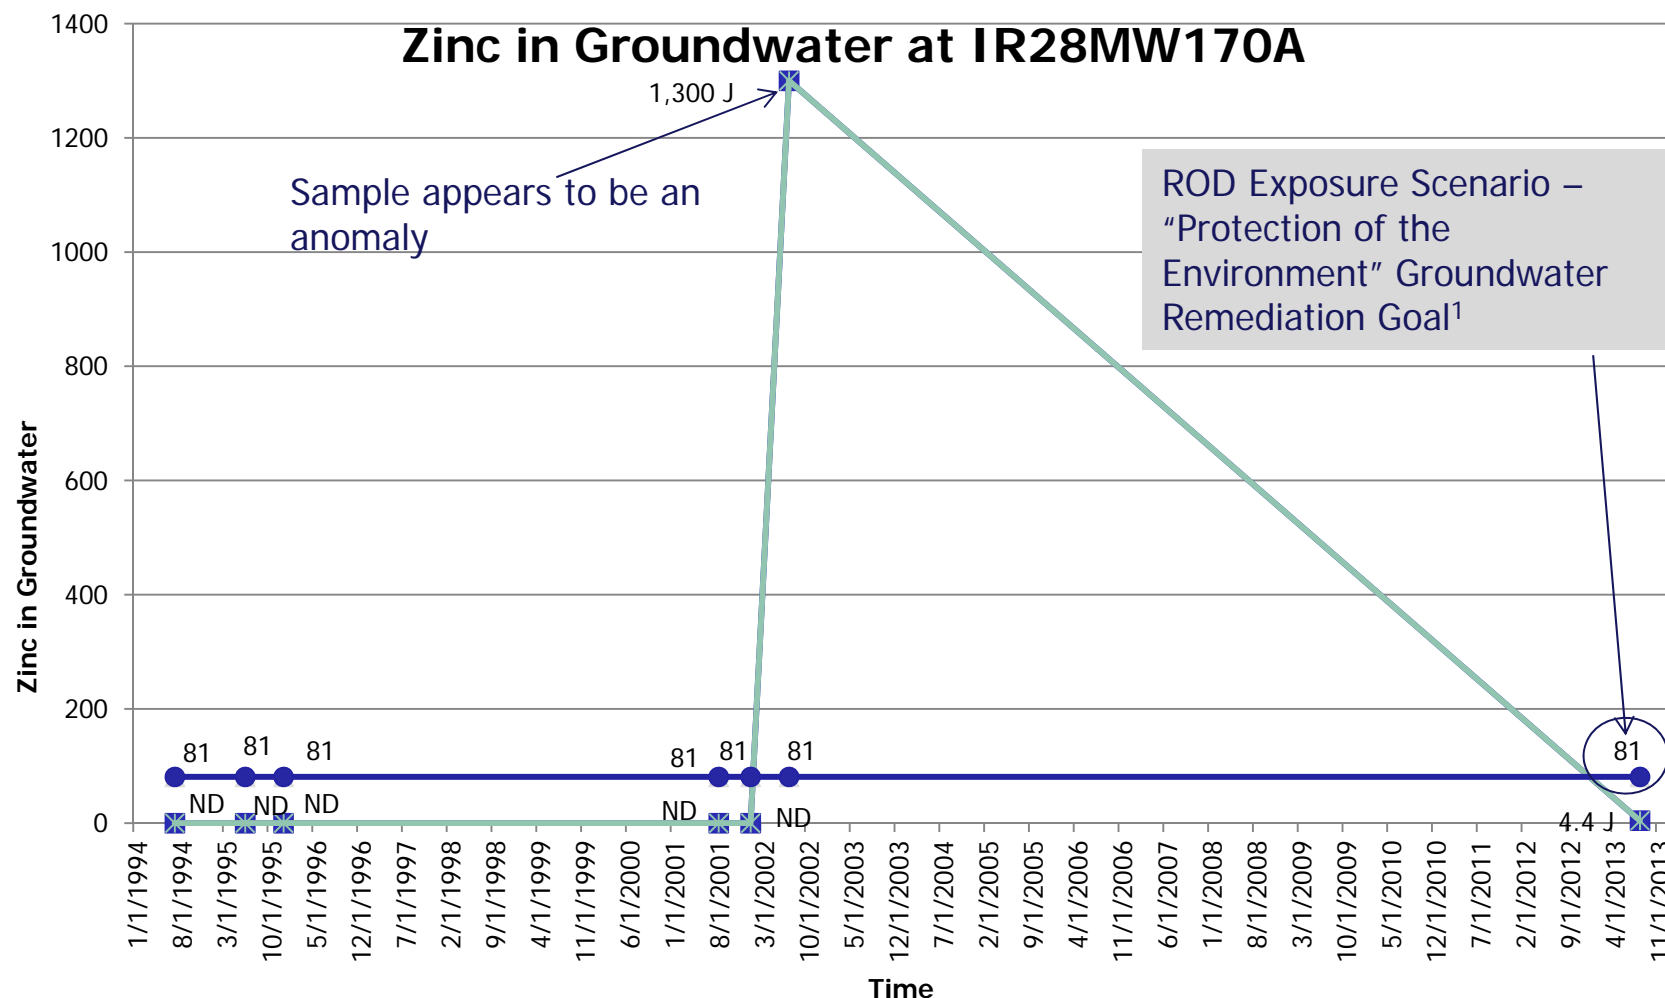
## Sample Results for Zinc in Groundwater – IR28MW170A (Plume C1-5)

<sup>1</sup> Notes in ROD for Parcel C, Table 4: Protection of the Environment prevents or minimizes discharge that would be above the specified remediation goals; specific trigger levels are developed for each plume. Groundwater remediation goals for chromium VI and zinc are at the point of discharge to the bay.

- The only historical sample containing zinc above the Parcel C ROD Remediation Goal and surface water quality criteria appears to have been an anomaly
- The validation report did not include validation of sample ID 0228E019, collected on 7/11/02
- Historic and recent filtered groundwater sample shows zinc below the RG and surface water quality criteria
- The anomalous high result was not validated and is not representative of the groundwater of that area or concentration trends.
- **Recommend removal of Plume C1-5 from areas requiring remediation**
